**Flood Control Project Maintenance
Levee Inspections**
LMA District Cover Sheet
Spring 2019 Levee Inspection Results

Reclamation District No. 2058 Pescadero

Spring 2019 Levee Inspection Results

Waterway			Bank	Unit Miles
Unit No. 01 Paradise Cut			Left	6.58
	Spring (March - May)	Summer (June - August)	(September - November) Fall	Winter (December - February)
Unit Maintenance Rating (Fall Only)				
Date of Inspection	5/6/2019 - 5/6/2019			
DWR Inspector	Alberto De Leon			
Accompanied By	Greg Pombo

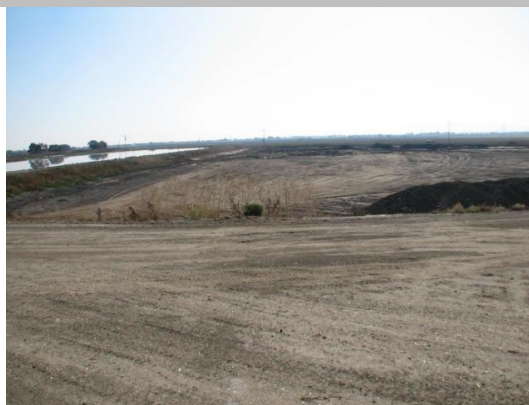
Photo 3 of 3 : SP_2019_RD2058_111_30_20190313_00019.jpg

LM Start	5.29	Rating **	U	Issue No.	30 (cont)
LM End	5.29	Issue Type +	En	Location *	LS

11/08/2011 Photo shows view from the levee looking to the left of the middle ramp.
